HISTORIC RESOURCES INVENTORY FORM
For Buildings and Structures

- 1. BUILDING NAME: Common: Wesleyan Hills Farmhouse Historic: Eben Hubbard House
- 2. TOWN/CITY: Middletown VILLAGE: _____ COUNTY: Middlesex
- 3. STREET & NUMBER (and/or location): Long Hill Road; east side, 2.5 miles south of Daniels St.
- 4. OWNER(S): Hill Development Corporation PUBLIC PRIVATE
- 5. USE: Present: Professional offices Historic: Residence
- 6. ACCESSIBILITY TO PUBLIC: Exterior visible from public road: yes no
Interior accessible: yes, explain _____ no

- 7. STYLE OF BUILDING: Second Empire DATE OF CONSTRUCTION: 1874-1875

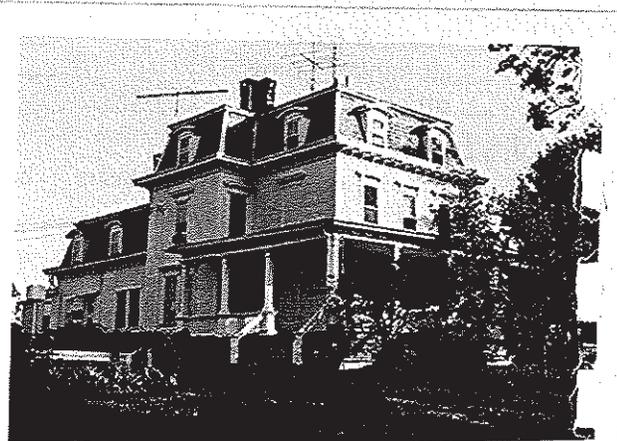
photographer: Elizabeth Loomis
date: 10/78 view: _____
negative on file: Roll 48, #27

The house has a cubical form displaying a typical mansard slate roof with dormers. Its decorative elements include a bracketed cornice and window caps. A wide verandah extends around the front facade. It has decorative columns, a bracketed cornice and side staircases. Attached to the rear of the building is a 1½-story wing with a mansard roof which conforms to the main block of the house. There are also three board-and-batten barns in the rear.

The Hubbard House is in well-preserved condition and is a good example of a style rarely found in rural districts in Middletown.
